Case Study: Surveying an Intersection, Anaheim, California

Date: October 2014

Location: La Palma Ave, Anaheim, California

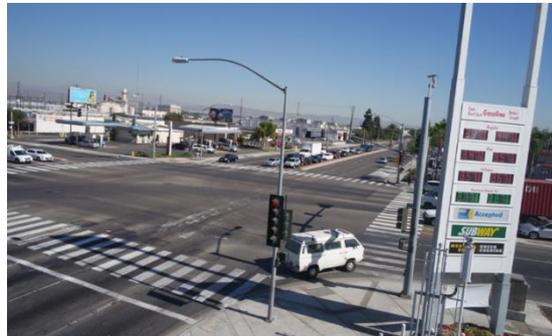
The required task was to survey and draft a 3D CAD plan, with a measurement accuracy of better than 2 centimeters (5-6 hundredths of a foot), of an intersection..

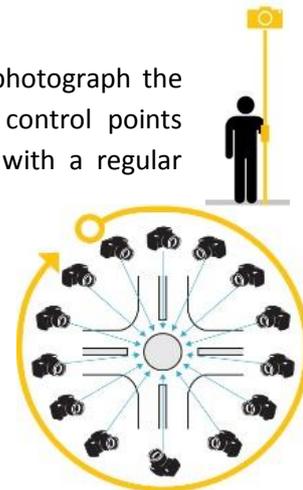
The time spent in the field was only 40 minutes: 20 minutes to photograph the intersection, and an additional 20 minutes to measure several control points throughout the intersection. The intersection was photographed with a regular Samsung Smart Camera NX mini camera (20-megapixel resolution) with a 9-mm wide-angle lens. A total of 50 images of the intersection were made from the perimeter of the intersection toward the middle, with an image taken about every 5 meters (25 feet). To minimize foreground obstructions in the images, the camera was elevated above ground level by mounting it on an 8-meter (25-foot) telescopic pole, and was remotely controlled using the Samsung smartphone application via Wi-Fi.

It is important to point out that, by surveying the intersection with a camera and a pole, the field crew was never required to enter the intersection. This permitted carrying out the survey during daytime while conforming to the strictest occupational safety requirements.

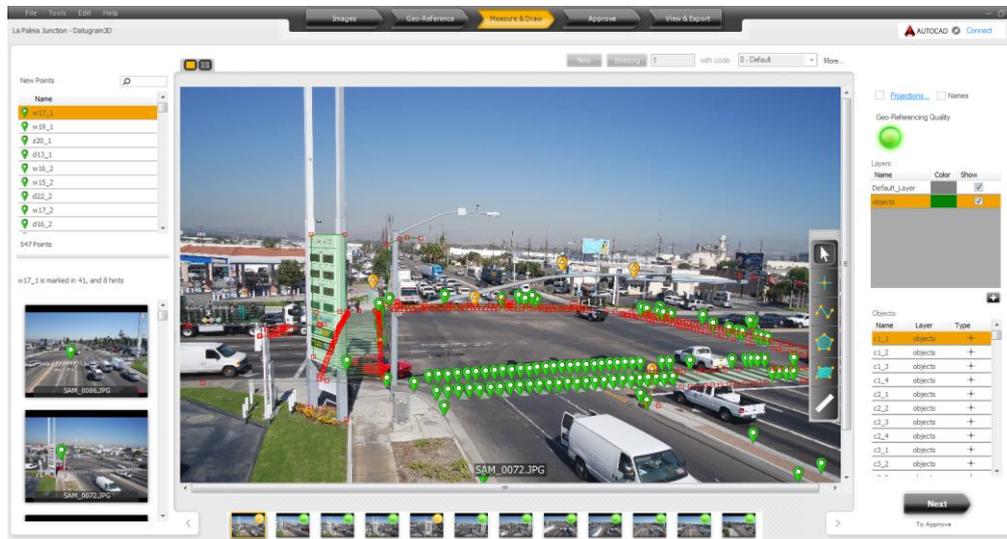
A total of 18 points were measured throughout the intersection using a prism-less Total Station device; 10 of these points were used as control points for the geo-referencing of the images. The selected control points were high-contrast, well-defined objects such as corners of road signs, corners of white marks painted on the road, etc.

The actual time in the office to geo-reference the images and draft the 3D CAD plan of the intersection directly on the images was about 5 hours.

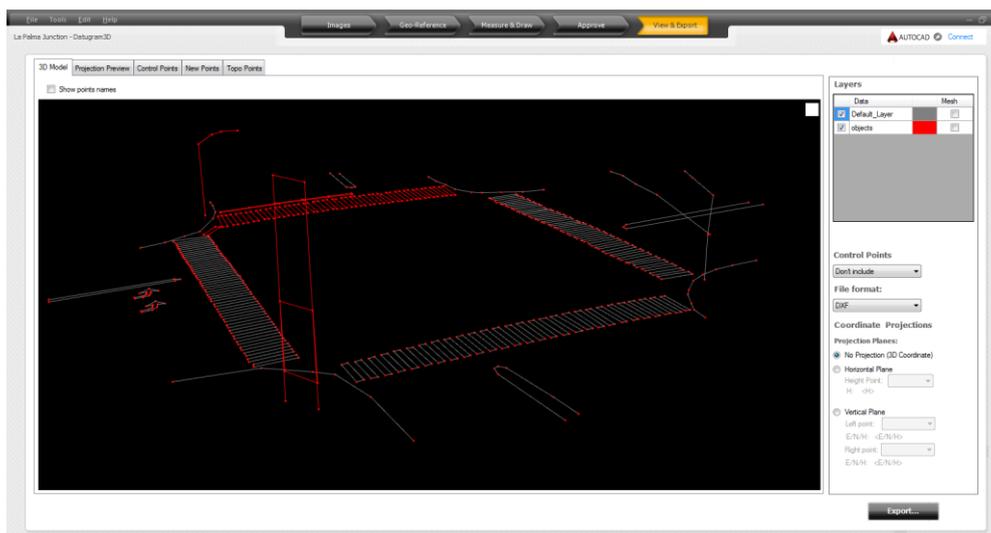
A 3D CAD model of the intersection in DXF format was generated by drafting directly on the oblique images using the DatuGram™3D application. In addition to the DXF file, a list of the measured points in PNT format was generated. This included the point names, codes, descriptions, coordinates, and their measurement accuracies in all axes. Overall, 547 new measurements were made from the images. The measurement accuracy of all points was better than 2 centimeters (5-6 hundredths of a foot) in both position and elevation.
